Doc. No: TSG_Milestone
Version: 1.0
Date: 2010-02-26

Title: Troubleshooting-Guide **Milestone**

Troubleshooting Guide Milestone Level 1+2

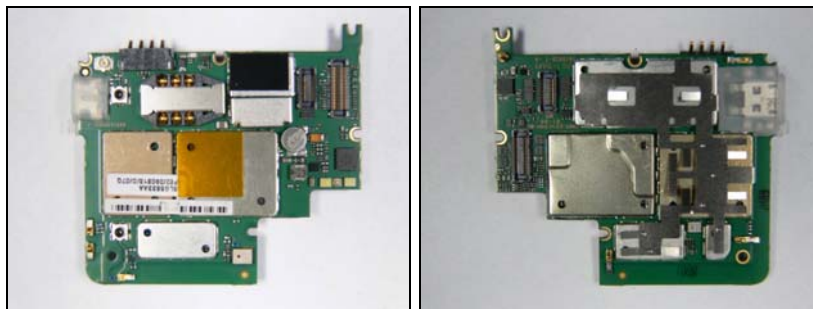
Figure 1

a) Transceiver board assembly defective

Verification: Temporarily replace the transceiver board assembly with a known good one. If the fault has been cleared forward to authorized Level 3 Service Center.

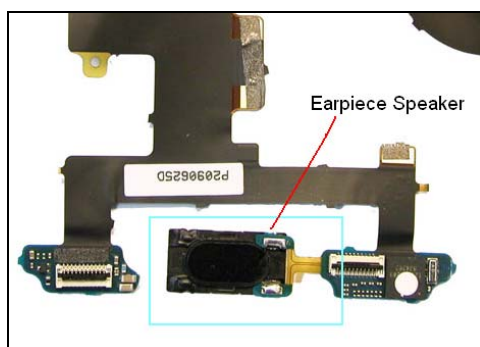
Figure 2

b) Assembly, PWA, Dynamic Flex , Speaker defective

Disassemble housing and replace Slider Front Assembly. If the failure is fixed change the dynamic Flex Assy where the earpiece speaker is assembled to (NOTE: if there is no touch screen functionality after replacement of the dynamic flex assy, make sure that it is preprogrammed

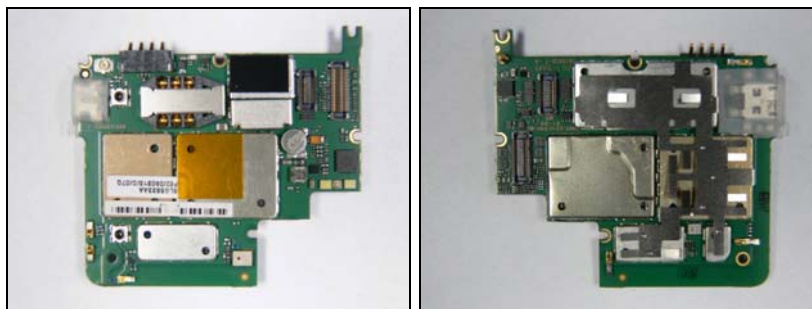
Figure 4

a) Transceiver board (“Assembly, PWA”) defective:

Replace transceiver with a known good one (or housing with a known good one) to verify if housing or PCB is defective. In case of defect transceiver, forward to an authorized level 3 service center.

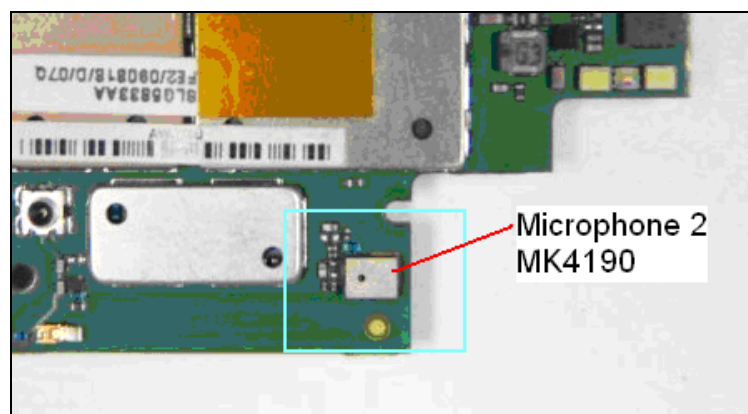
Figure 5

The microphone 2 (MK4190) is on the “Assembly PWA” the transceiver board.

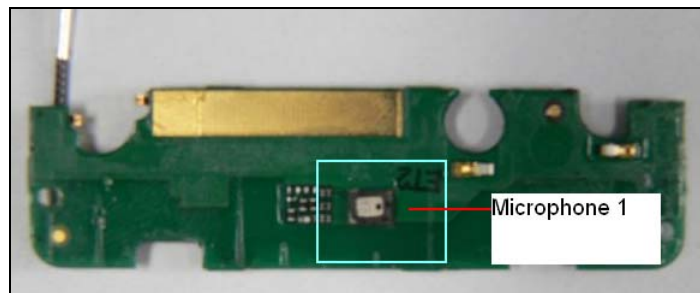
Figure 6

b) Microphone 1

The microphone 1 is located on the audio PCB (Assembly, Printed Circuit Board, Audio) in the front housing ("Slider Front Assembly"). Make sure that no dust or foreign particles are on microphone hole from outside. Disassemble housing and replace with a known good housing ("Assembly, Housing, Front"). Check also the vibrator flex cable that is the connection to the audio board (aligned to the Assembly, Chassis, Guide Metal Flex).

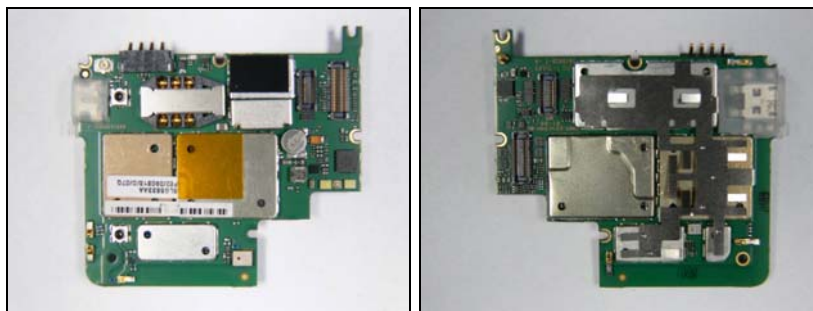
Figure 9

a) Transceiver board ("Assembly, PWA") defective:

Replace transceiver with a known good one (or housing with a known good one) to verify if housing or PCB is defective. In case of defect transceiver, forward to an authorized level 3 service center.

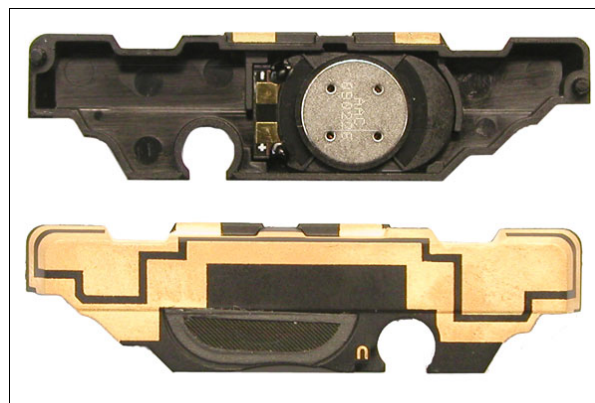
Figure 10

b) Faulty alert "Loudspeaker, dynamic"

Remove rear housing and temporarily replace the acoustic chamber with a known good one. If the fault has been cleared, reassemble with a new one.

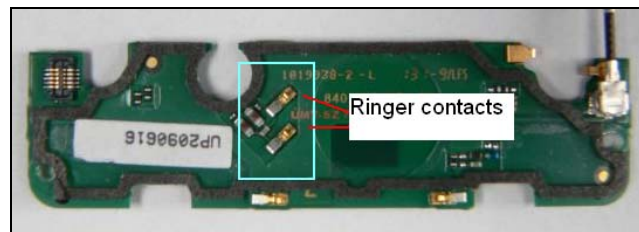
Figure 11

c) Faulty audio PCB (Assembly, Printed Circuit Board, Audio)

Remove rear housing assy and check contacts on “Assembly, Printed Circuit Board, Audio”.

If clean and not bent, temporarily replace audio PCB assy with a known good one. If the fault has been cleared, reassemble with a new one.

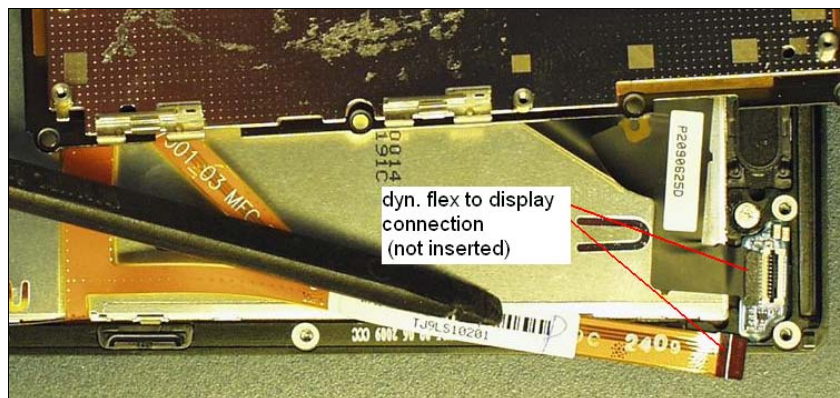
Figure 14

b) Connections from transceiver board to display faulty

Check J5200 Slider Connector on transceiver board (figure 13), dynamic flex ("Assembly, PWA, dynamic flex", figure 3) and finally the display itself in the front housing, figure 3 / 14) for damage or dust. Replace step by step to find out what part is defect.

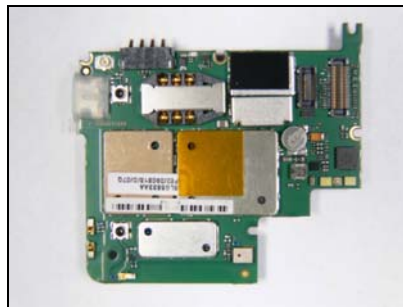
Figure 16

c) Faulty transceiver board assembly

Verification: Temporarily replace the transceiver board assembly with a known good one. If the fault has been cleared, forward to an authorized Level 3 Service Center.

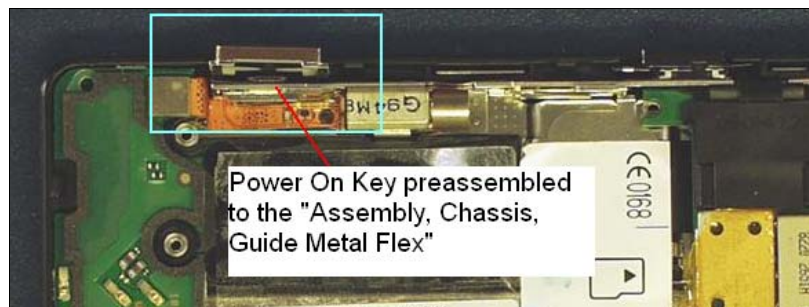
Figure 17

d) Power On Key defective

If the telephone turns on via EMU USB cable and is unable to power down after pressing the ON/OFF button, it could be because of a faulty "Assembly, Chassis, Guide Metal Flex" where the side keys are assembled to. For verification reassemble the unit with a known good back housing. If the fault has been cleared, replace with a new "Assembly, Chassis, Guide Metal Flex".

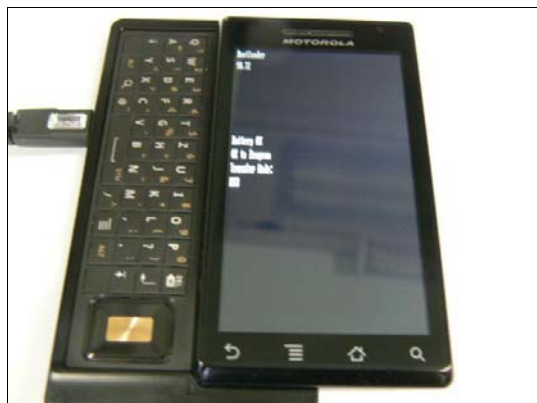
Figure 18

If the phone doesn't start because of corrupted software it might be possible to recover it with RSDnet connected. Connect phone to EMU-cable **while** holding down "Navigation Up" key. The phone should start in flash mode now: *S Flash OMAP3430*

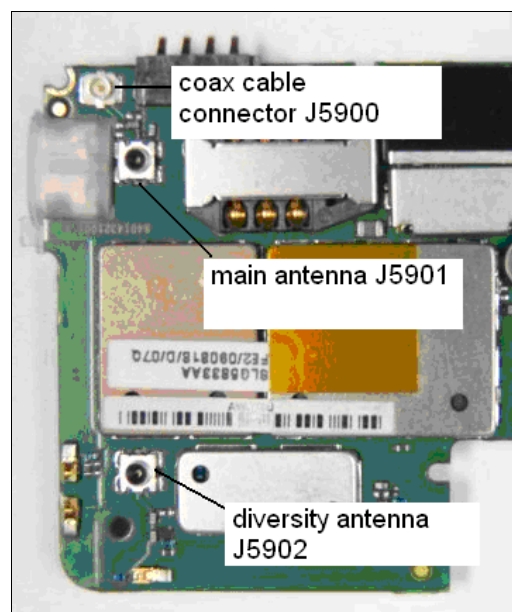
Figure 19

a) Faulty transceiver board assembly

Verification: Temporarily replace the transceiver board assembly with a known good one.
 If the fault has been cleared, first check antenna sockets for damage or dust.
 If ok, forward to an authorized Level 3 Service Center.

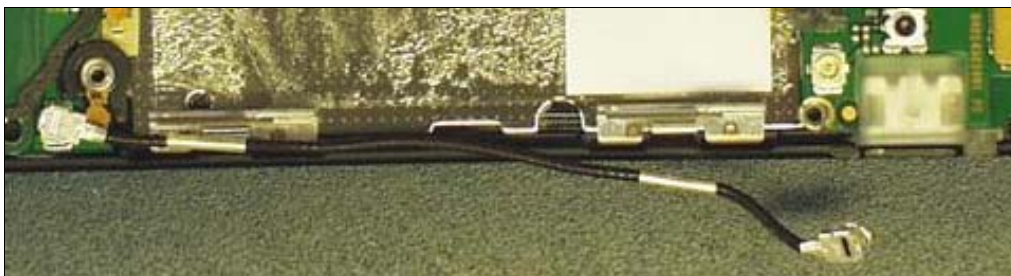
Figure 20

b) Faulty "Cable Coax"

Verification: Temporarily replace the coax cable with a known good one. If ok, replace it with a new one.

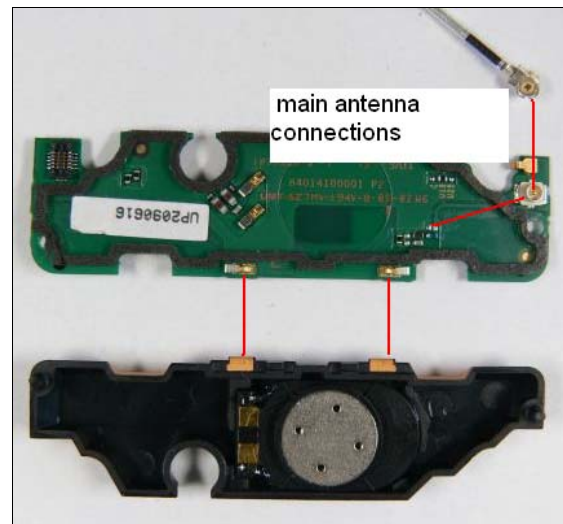
Figure 21

c) Damaged or misaligned acoustic chamber

The main antenna is molded on the acoustic chamber ("Housing, Acoustic Chamber, Main Antenna"). Check for damage or misalignment (figure 27/28)

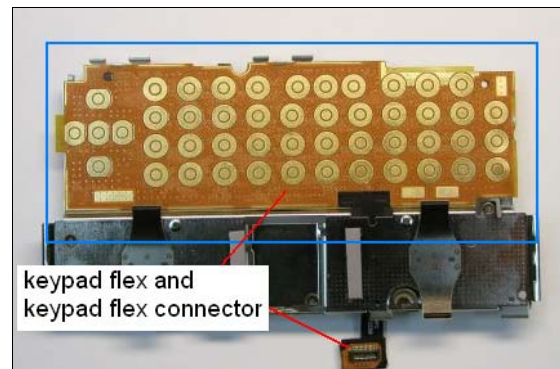
Figure 23

b) Faulty keypad flex

Verification: Temporarily replace the front housing with a known good one. If ok, replace the "Flex, Keypad, Large Spacebar"

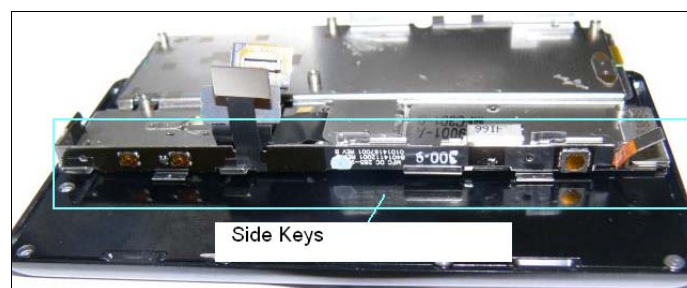
Figure 24

a) Faulty side key flex

The side keys are assembled to the "Assembly, Chassis, Metal Guide Flex".

Verification: Temporarily replace the front housing with a known good unit like in picture below. If ok, replace with a new "Assembly, Chassis, Metal Guide Flex".

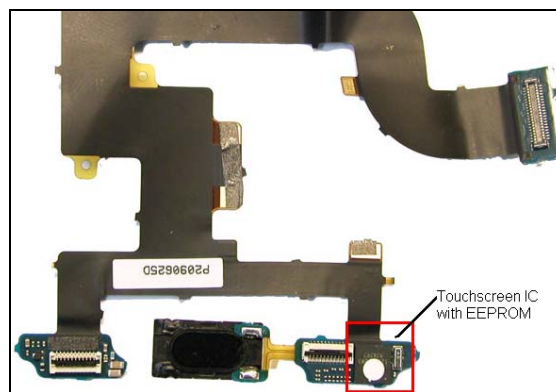
Figure 25

b) Assembly, PWA, Dynamic Flex

Disassemble housing and replace Slider Front Assembly. If the failure is fixed change the dynamic Flex Assy (NOTE: if there is no touch screen function after replacement of the dynamic flex assy, make sure that it is pre programmed !).

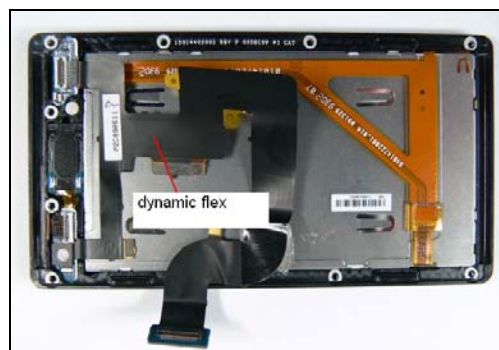
Figure 26

c) Assembly, Housing Slider Service defect

Disassemble the housing and temporarily replace Slider Front Assembly Service with a known good one. If the failure is cleared, but not caused by the dynamic flex, replace the Housing Slider Assy with a new one.

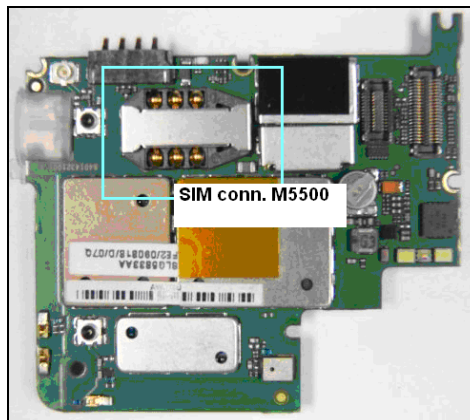
Figure 27

a) Faulty SIM connector on transceiver board assembly or faulty transceiver board assy

If the fault has not been cleared after cleaning the contacts, forward to an authorized Level 3 Service Center.

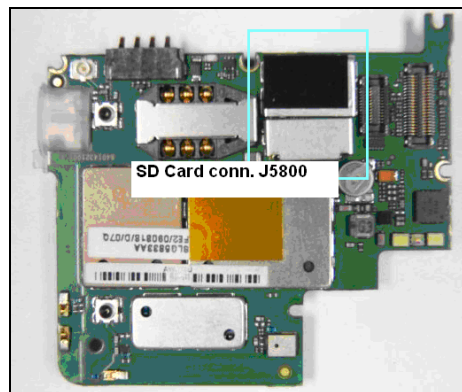
Figure 28

a) Faulty SD Card connector on transceiver board assembly or faulty transceiver board assy

If the fault has not been cleared after cleaning the contacts, forward to an authorized Level 3 Service Center.

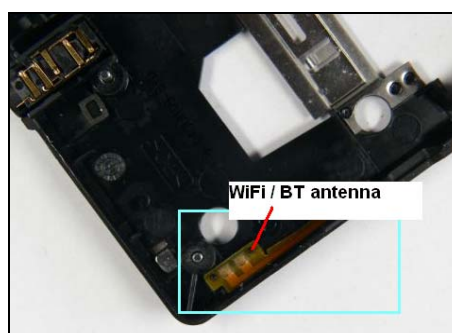
Figure 29

c) Assembly, Housing, Rear, Service

Disassemble the rear housing and temporarily replace with a known good one. If the failure is cleared replace the "Assembly, Housing, Rear, Service" with a new one.

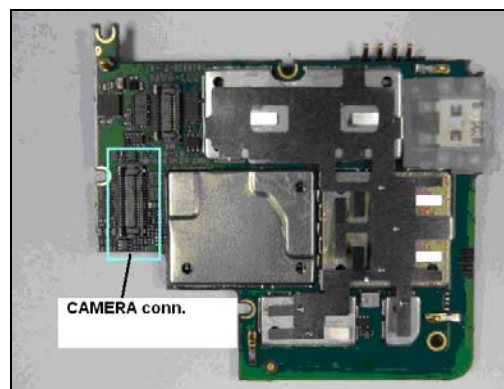
Figure 30

a) Faulty transceiver board assembly

Verification: Temporarily replace the transceiver board assembly with a known good one and try to capture a picture. If the fault has been cleared, forward to an authorized Level 3 Service Center.

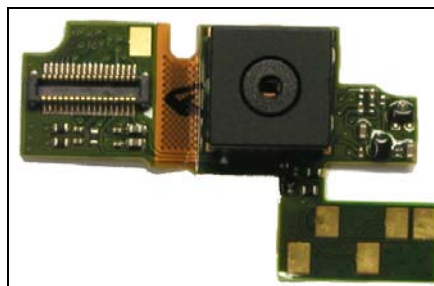
Figure 31

b) Faulty camera (Camera, Assembly, MP Imager)

Verification: Temporarily replace the camera with a known good one. It's connected to the transceiver board.

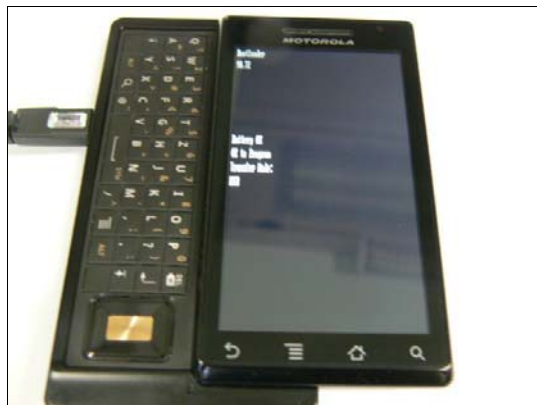
Figure 32

If the phone doesn't start because of corrupted software it might be possible to recover it with RSDnet connected. Connect phone to EMU-cable **while** holding down "Navigation Up" key. The phone should start in flash mode now: *S Flash OMAP3430*

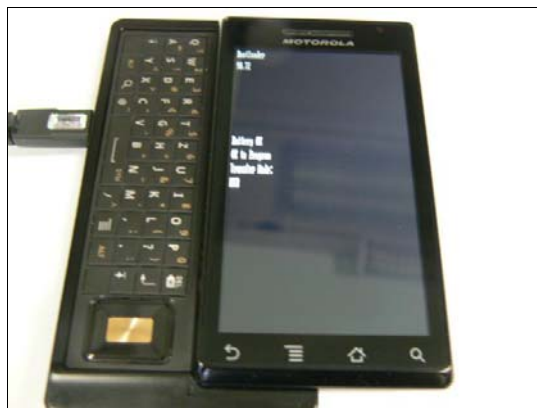
Figure 33

If the phone doesn't start because of corrupted software it might be possible to recover it with RSDnet connected. Connect phone to EMU-cable **while** holding down "Navigation Up" key.

The phone should start in flash mode now: *S Flash OMAP3430*
